**Flood Control Project Maintenance  
Levee Inspections**  
**LMA District Cover Sheet**  
**Spring 2017 Levee Inspection Results**

**Reclamation District No. 0556 Upper Andrus**

**Levee Inspection Report By Mile - Spring 2017**

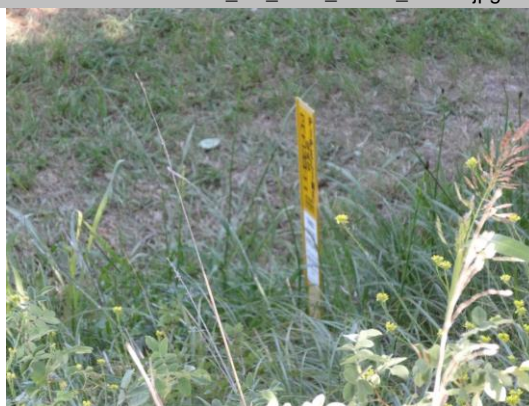
Photo 1 of 3 : UCIP\_SP\_2017\_45564\_74151.jpg

LM Start	0.44	Rating **	M	Issue No.	387
LM End	0.44	Issue Type +	En	Location *	WS
Category	Supplemental			GPS Latitude/Longitude	
				Start	End
Item	DWR UCIP Field Study			38.233537 °	38.233537 °
				-121.520483 °	-121.520483 °
DWR ID					
Comment Code					
Inspector Comment					
FS_ID:45564					
DS_ID:20820					
EP_NO: 3448					
Repair Type: Non-Urgent					
Crossing Status: Indicator Found					
UCIP Comments: Dense vegetation inhibited visibility of gasline marker on WS. Need to contact owner to determine status of crossing.					
FIELD_STRUCT_DESC: 4-1/2-inch steel pipe gas line through levee, 4.0 feet below the crown. Location marker on waterward shoulder. (App. 3448-PG&E pipe not located 2/91). Cut in pavement visible at crossing.					
Gasline marker on LS and opposite bank at RD 263.					
FS Date: 5/27/2015

Gasline marker present on LS.

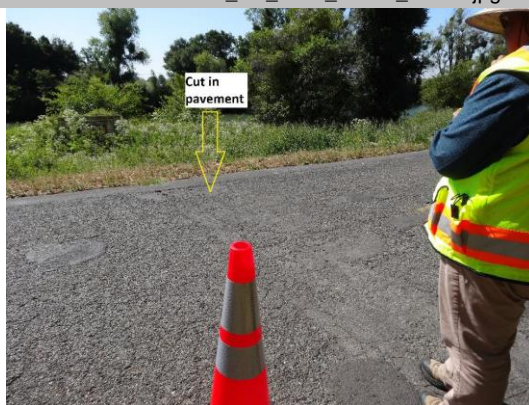
Photo 2 of 3 : UCIP\_SP\_2017\_45564\_74146.jpg

View of WS; cut in pavement in alignment with arrow and Olivia indicating location of crossing trench.

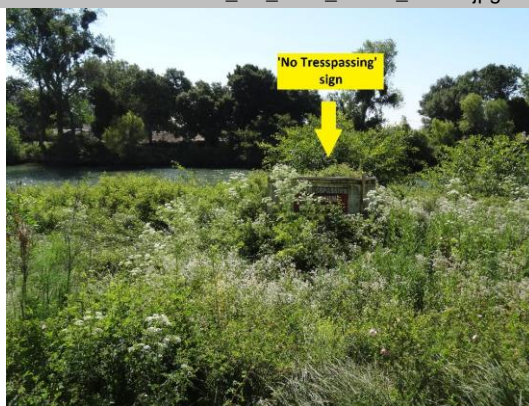
Photo 3 of 3 : UCIP\_SP\_2017\_45564\_74152.jpg

View of WS. Dense vegetation limited visibility of 'No Trespassing' sign.

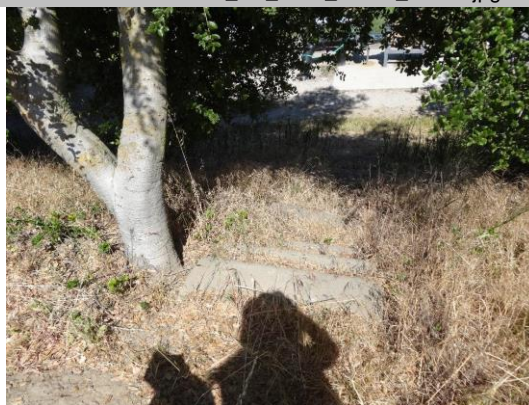
Photo 1 of 3 : UCIP\_SP\_2017\_45663\_74180.jpg

LM Start	0.53	Rating **	M	Issue No.	388
LM End	0.53	Issue Type +	En	Location *	WS
Category	Supplemental			GPS Latitude/Longitude	
				Start	End
Item	DWR UCIP Field Study			38.232450 °	38.232450 °
				-121.521624 °	-121.521624 °
DWR ID					
Comment Code					
Inspector Comment					
FS_ID:45663 DS_ID:20821 EP_NO: 5548 Repair Type: Non-Urgent Crossing Status: Found UCIP Comments: Dense vegetation prevents inspection of WS slope. FIELD_STRUCT_DESC: 12-inch steel pipe through levee, 5.0 feet below crown. 1-1/4-inch electrical conduit through the levee. Concrete steps on landward slope. Pump off landward toe. Cuts visible on pavement. (App. 5548). FS Date: 5/13/2015

Concrete steps on LS slope.

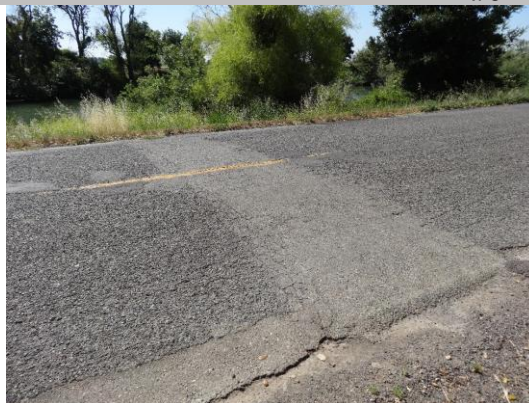
Photo 2 of 3 : UCIP\_SP\_2017\_45663\_74181.jpg

View of WS with cuts visible on pavement.

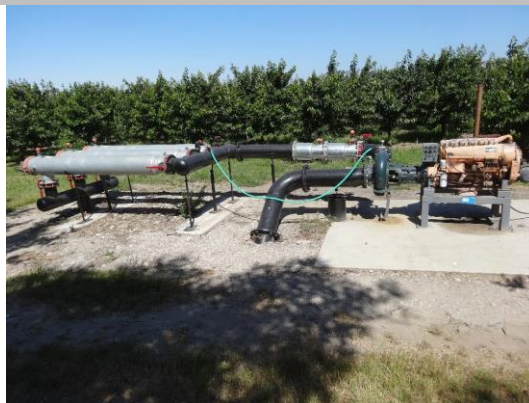
Photo 3 of 3 : UCIP\_SP\_2017\_45663\_74182.jpg

Pump and pipe into levee off LS toe.

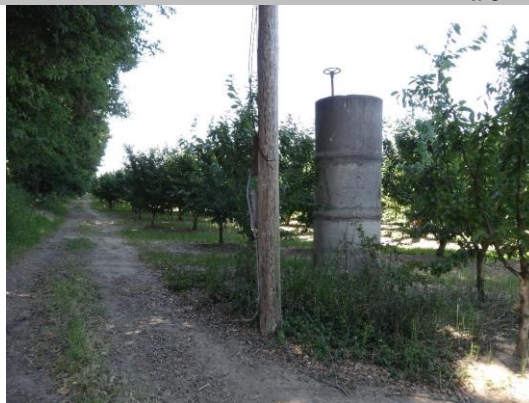
Photo 3 of 3 : UCIP\_SP\_2017\_45664\_74192.jpg

Standpipe and service pole visible off LS toe.

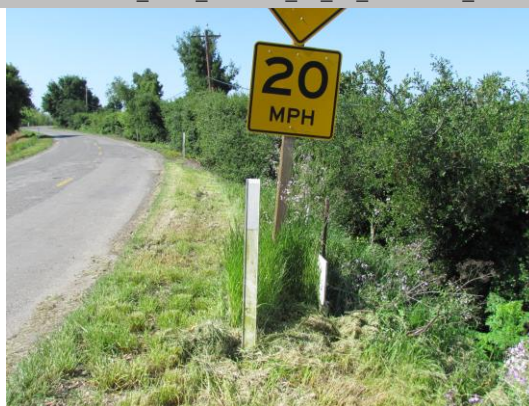
Photo 1 of 1 : SP\_2017\_RD0556\_18\_10\_20170517\_00057.jpg

LM Start	0.80	Rating **	M	Issue No.	12
LM End	3.36	Issue Type +	Ma	Location *	LS
Category	Earthen Levee			GPS Latitude/Longitude	
				Start	End
Item	Animal Control			38.229459 °	38.208959 °
				-121.524805 °	-121.541368 °
DWR ID	DWR_RD0556_01_s_2012_12				
Comment Code					
A1 : Exterminate rodents and backfill and compact or grout burrows.					
Inspector Comment					
Extermininate rodents and backfill and compact burrows.

RD 556 Unit 1 levee miles 0.93-1.54 looking downstream landside slope.

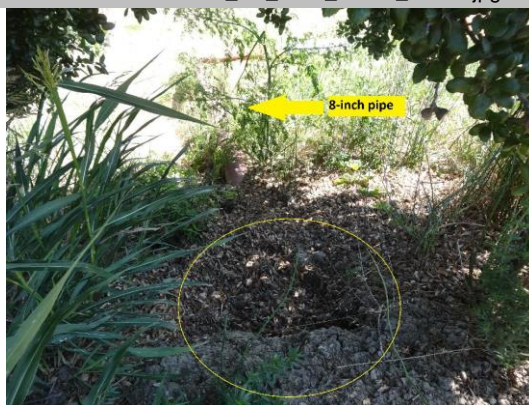
Photo 1 of 3 : UCIP\_SP\_2017\_46799\_74739.jpg

LS view: 8-inch pipe off LS slope with possible erosion above pipe (circled).

FS\_ID:46799  
DS\_ID:25106  
EP\_NO: N/A  
Repair Type: Non-Urgent  
Crossing Status: Found  
UCIP Comments: Possible erosion above pipe on LS needs attention.  
FIELD\_STRUCT\_DESC: 8-inch steel irrigation pipe unknown feet below crown visible on LS 6 ft away from 10-inch pipe. Post likely for protection of vent located off the crown on shoulder. Electric pole next to pipe on LS.  
FS Date: 5/27/2015

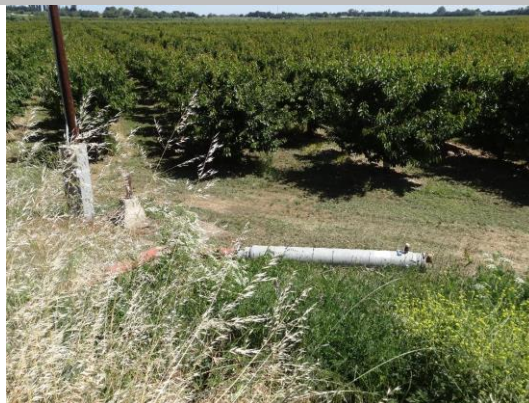
Photo 3 of 3 : UCIP\_SP\_2017\_46799\_74741.jpg

Electric pole next to pipe on LS.

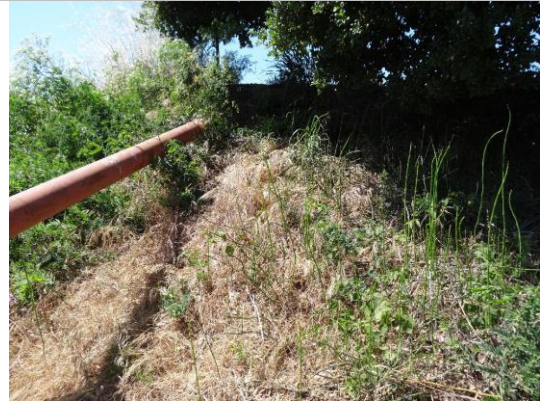
Photo 3 of 3 : UCIP\_SP\_2017\_45683\_74202.jpg

FS\_ID:45683  
DS\_ID:20823  
EP\_NO: 11169  
Repair Type: Non-Urgent  
Crossing Status: Found  
UCIP Comments: Appears abandoned in place and if so should be done so properly. Dense vegetation on WS limits visibility.  
FIELD\_STRUCT\_DESC: 10-inch pipe through levee, 3.8 feet below crown. (Lower end of rock revetment)(ABO 11169 - Mealer and 4848).  
Abandoned in place. O&M Manual Sac 103, June 1954  
FS Date: 5/27/2015

View up LS slope. 10" pipe (not visible) rests next to (visible) 8" pipe.

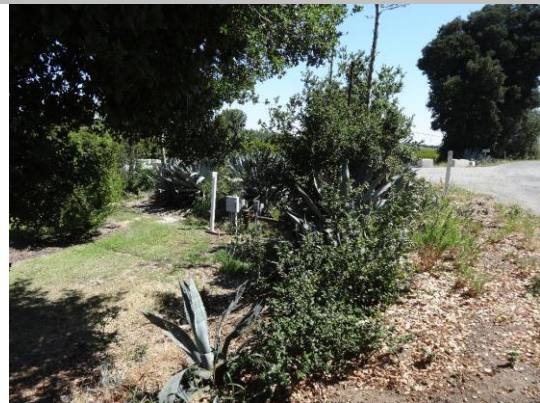
Photo 1 of 3 : UCIP\_SP\_2017\_45692\_74204.jpg

Comment Code					
Inspector Comment					
FS_ID:45692 DS_ID:20825 EP_NO: 13302 Repair Type: Non-Urgent Crossing Status: Found UCIP Comments: Seal beneath siphon breaker off LS toe leaking. Rodent activity near crown off LS shoulder. Need to contact owner about leaky seal. Dense vegetation prevented inspection of WS slope. FIELD_STRUCT_DESC: 6-inch steel pipe and 2-inch GI electrical conduit through levee 2 feet below crown; roadway with siphon valve on landward shoulder. Concrete stand and pump on landward toe; circuit box also. Cuts visible on pavement. 6-inch PVC standpipe adjacent to pipe off LS toe. (Kay Dix Ranch App. 13302). O&M Manual Sac 103, June 1954 FS Date: 5/27/2015

Pipe, standpipe, electrical box at LS toe. Pumphouse in bush behind electrical box.

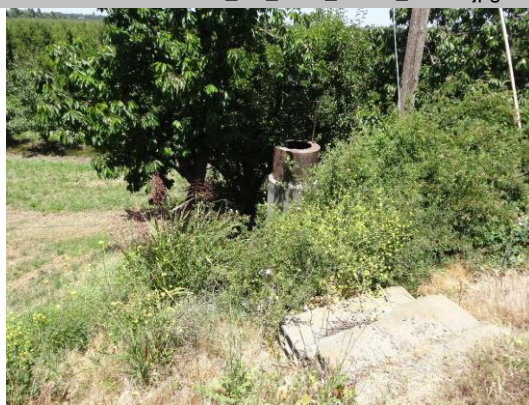
Photo 1 of 3 : UCIP\_SP\_2017\_45743\_74240.jpg

Concrete standpipe and steps off LS toe.

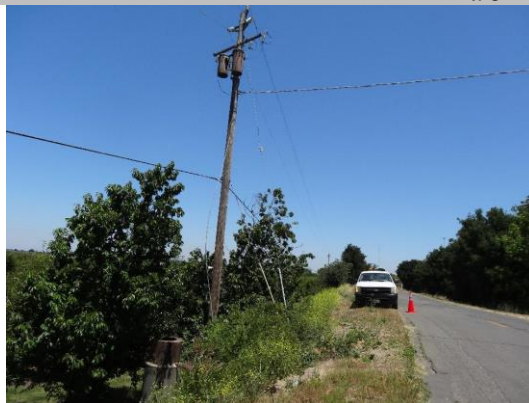
Photo 2 of 3 : UCIP\_SP\_2017\_45743\_74241.jpg

Service pole next to standpipe off LS toe.

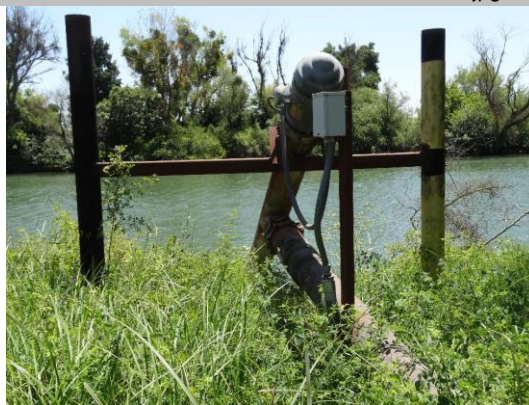
Photo 3 of 3 : UCIP\_SP\_2017\_45743\_74242.jpg

Slant pump and pipe with 2" electrical conduit into WS slope.

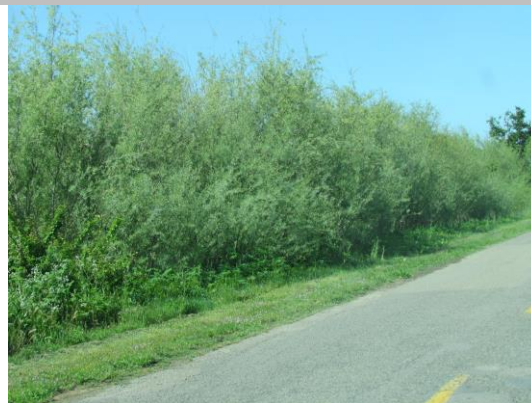
Photo 1 of 1 : SP\_2017\_RD0556\_18\_74\_20170517\_00060.jpg

RD 556 Unit 1 waterside levee mile 1.74-2.29.

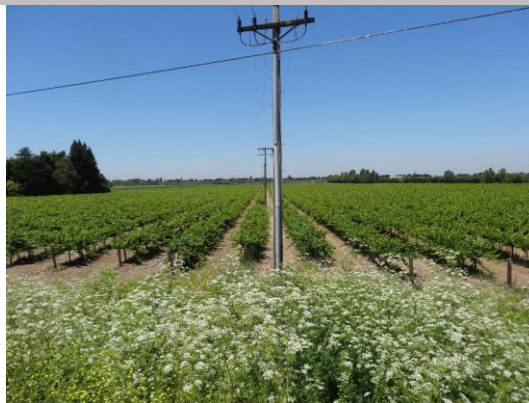
Photo 2 of 3 : UCIP\_SP\_2017\_45746\_74251.jpg

FS\_ID:45746  
DS\_ID:20828  
EP\_NO: 3735  
Repair Type: Non-Urgent  
Crossing Status: Indicator Found  
UCIP Comments: Dense vegetation on LS and WS limited accessibility.  
FIELD\_STRUCT\_DESC: 4-inch electric conduit through levee, 4.0 feet below the crown. Pump on berm. Underground submarine cable crossing. (App. 3735-PG&E). Electric pole on LS in alignment with cuts in pavement.  
FS Date: 5/27/2015

Cuts in pavement in alignment with electric pole off LS toe.

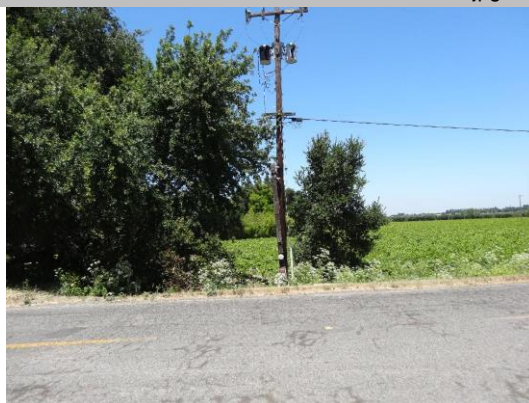
Photo 1 of 3 : UCIP\_SP\_2017\_45764\_74260.jpg

LS view: service pole on LW slope. Standpipe not visible in photo.

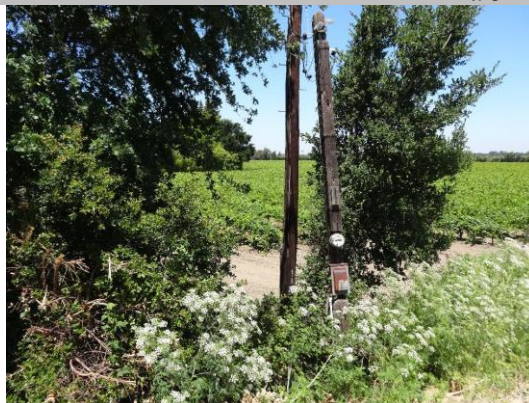
Photo 2 of 3 : UCIP\_SP\_2017\_45764\_74261.jpg

Pole on LS slope with electric box and 2-inch conduit.

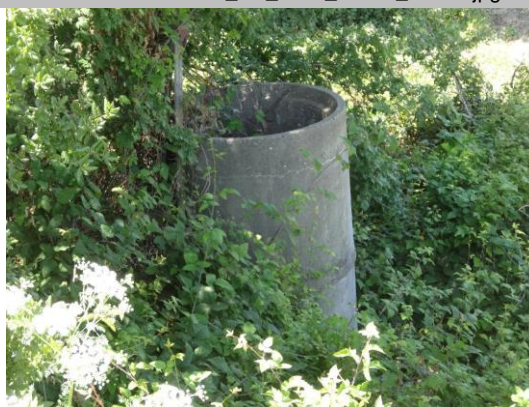
Photo 3 of 3 : UCIP\_SP\_2017\_45764\_74262.jpg

Standpipe on LS next to service pole.

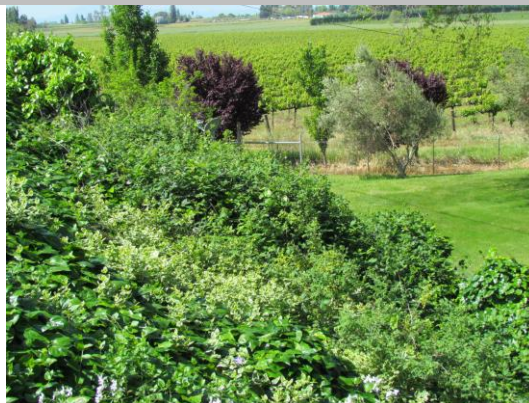
Photo 1 of 1 : SP\_2017\_RD0556\_18\_30\_20170517\_00061.jpg

Looking at the landside shoulder and slope at the unauthorized berry vines.

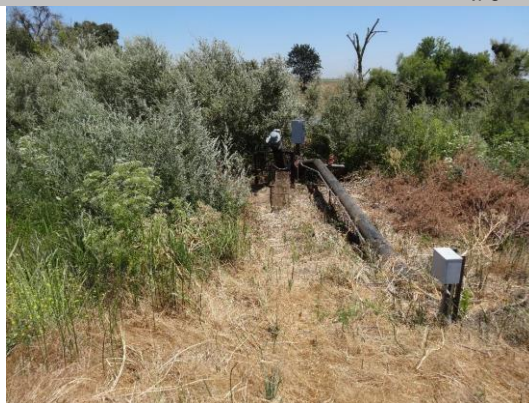
Photo 1 of 3 : UCIP\_SP\_2017\_45786\_74280.jpg

WS view: Slant pump, 12-inch and 1-inch pipe through levee.

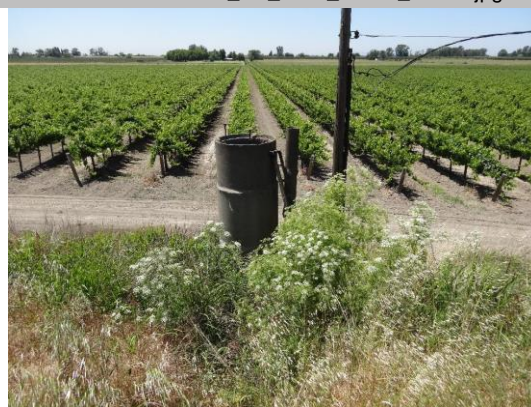
Photo 3 of 3 : UCIP\_SP\_2017\_45786\_74282.jpg

LS: 2 standpipes and service pole.

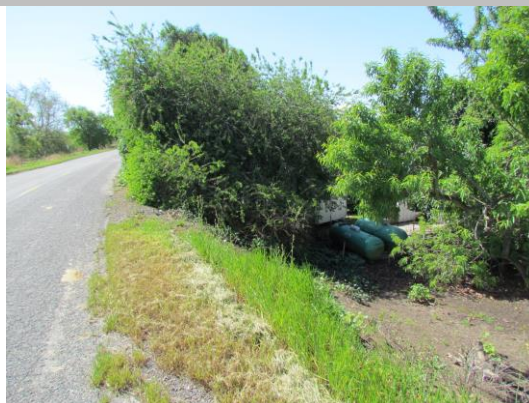
Photo 1 of 1 : SP\_2017\_RD0556\_18\_31\_20170517\_00063.jpg

Looking downstream from the landside shoulder woody tree growth blocking the slope and shoulder.

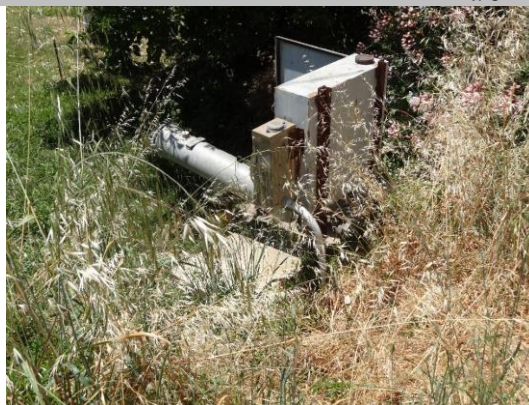
Photo 2 of 3 : UCIP\_SP\_2017\_45803\_74286.jpg

Closeup of 8-inch pipe, electrical conduit and box at LS berm.

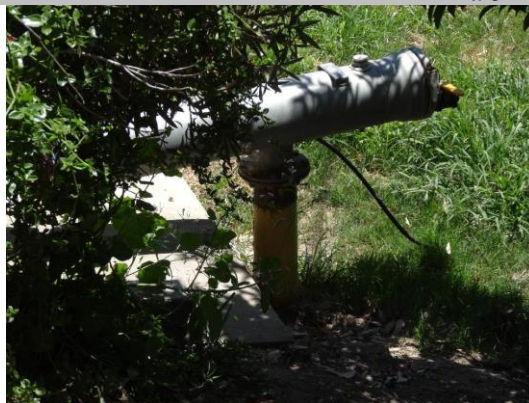
Photo 3 of 3 : UCIP\_SP\_2017\_45803\_74287.jpg

Closeup of 8-inch and 1.5-inch pipes and platform off LS toe.

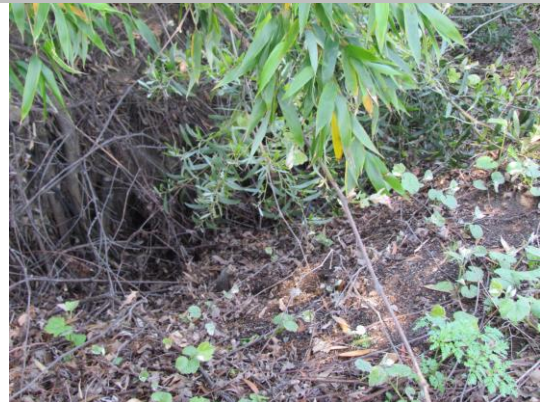
Photo 1 of 2 : SP\_2017\_RD0556\_18\_33\_20170517\_00065.jpg

RD 556 Unit 1 levee mile 2.72 fallen tree damage to shoulder and slope.

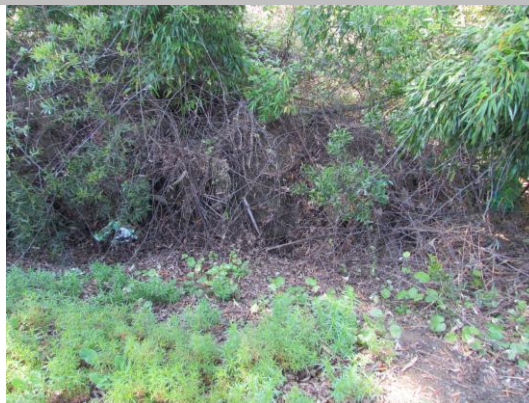
Photo 2 of 2 : SP\_2017\_RD0556\_18\_33\_20170522\_00067.jpg

RD 349 Unut 1 levee mile 2.72 the root ball of the fallen tree on slope landward.

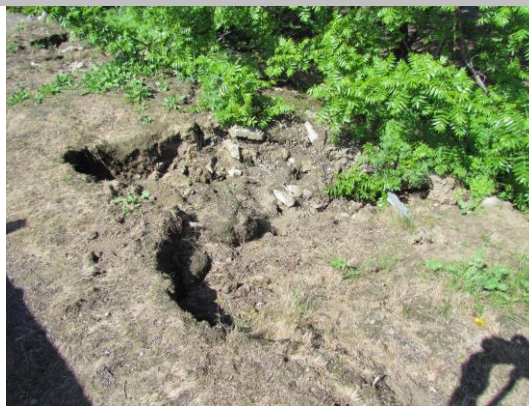
Photo 1 of 2 : SP\_2017\_RD0556\_18\_36\_20170522\_00069.jpg

556 Unit 1 levee mile 3.22 landside slope erosion.

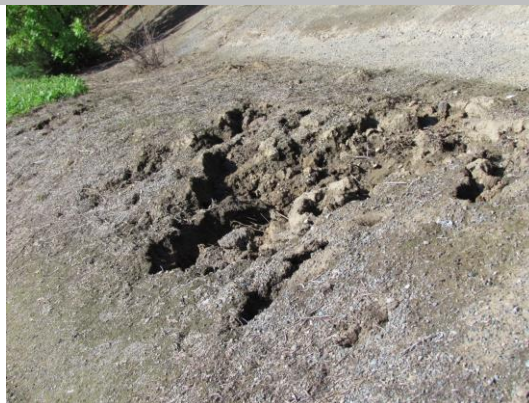
Photo 1 of 1 : SP\_2017\_RD0556\_18\_37\_20170522\_00071.jpg

556 Unit 1 levee mile 3.24 landside slope.

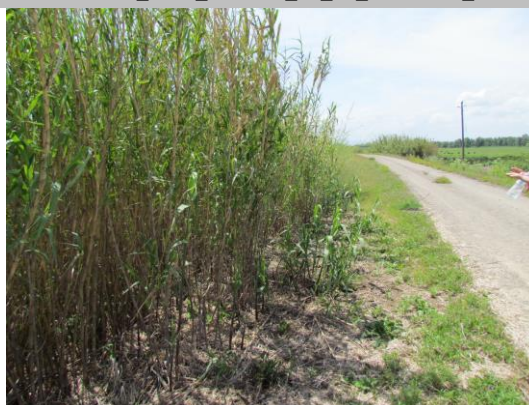
Photo 1 of 1 : SP\_2017\_RD0556\_18\_67\_20170523\_00074.jpg

Looking downstream on the waterside arundo completely blocking view of the slope and shoulder.

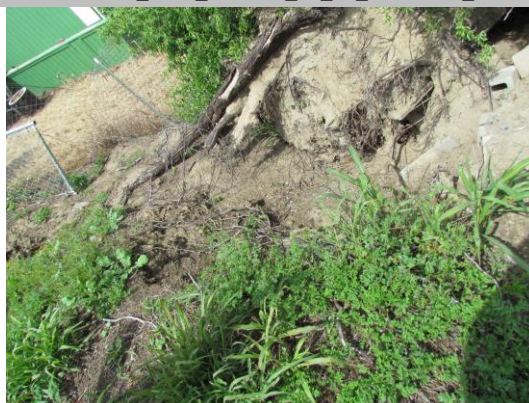
Photo 1 of 2 : SP\_2017\_RD0556\_18\_44\_20170523\_00075.jpg

RD 556 Unit 1 levee mile 5.46 fallen tree on landside slope and damage to the slope.

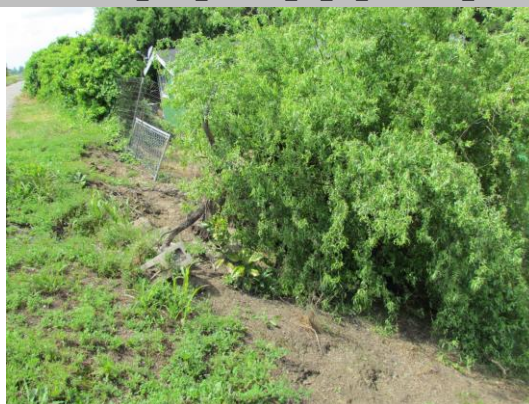
Photo 2 of 2 : SP\_2017\_RD0556\_18\_44\_20170523\_00076.jpg

view from upstream.

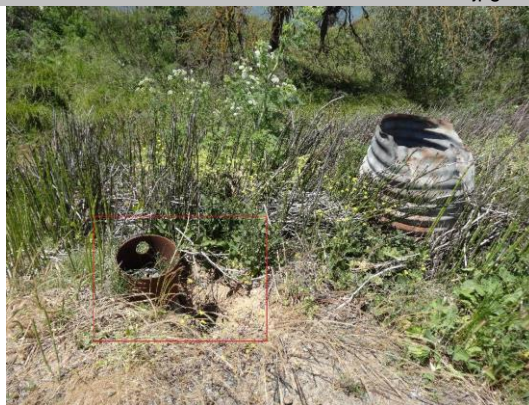
Photo 2 of 3 : UCIP\_SP\_2017\_12527\_20296.jpg

WS- siphon breaker and abandoned CMP riser laying adjacent to it.

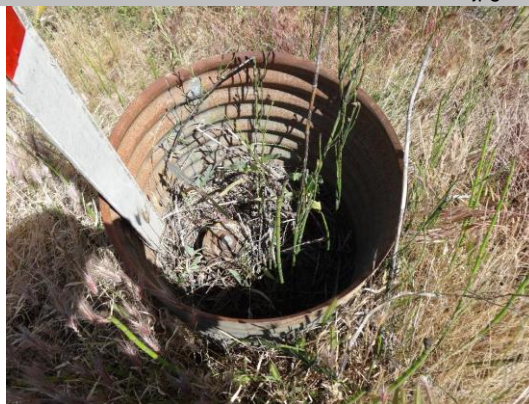
Photo 3 of 3 : UCIP\_SP\_2017\_12543\_20300.jpg

LS- siphon breaker in CMP riser. It needs cleaning.

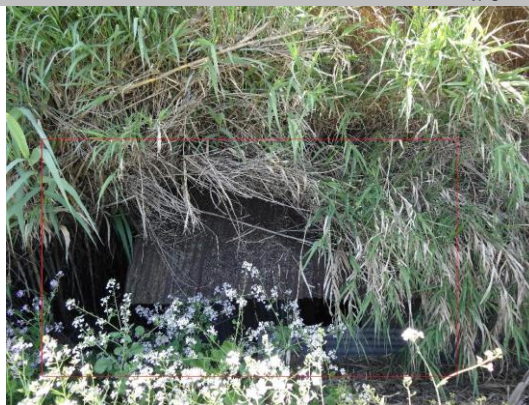
Photo 2 of 3 : UCIP\_SP\_2017\_12545\_20309.jpg

WS- pump house inside the dense vegetation.

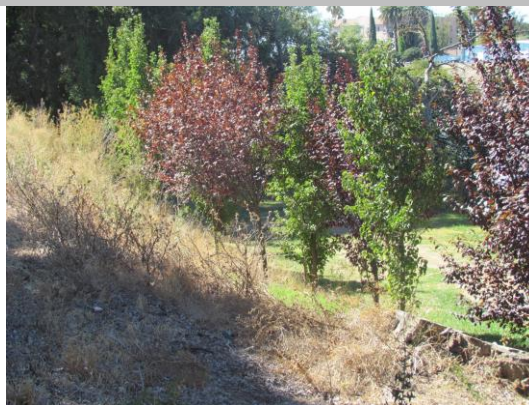
Photo 2 of 2 : SP\_2017\_RD0556\_19\_27\_20170404\_00012.jpg

RD 556 Unit 2 levee mile 2.16-2.19 waterside toe looking downstream.
